RESULTS OF DEVIATION MEASUREMENTS AND GEOMETRY OF ROTARY KILN No 1

AT EXEMPLARY CEMENT PLANT

**PERIOD OF SURVEY:
30th of March - 16th of April, 2004**

FINAL REPORT ON KILN No 1

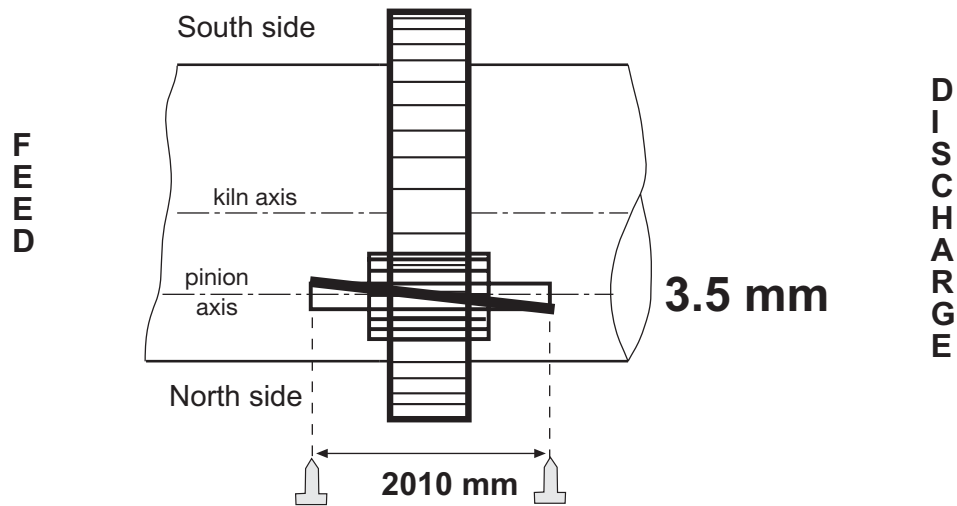
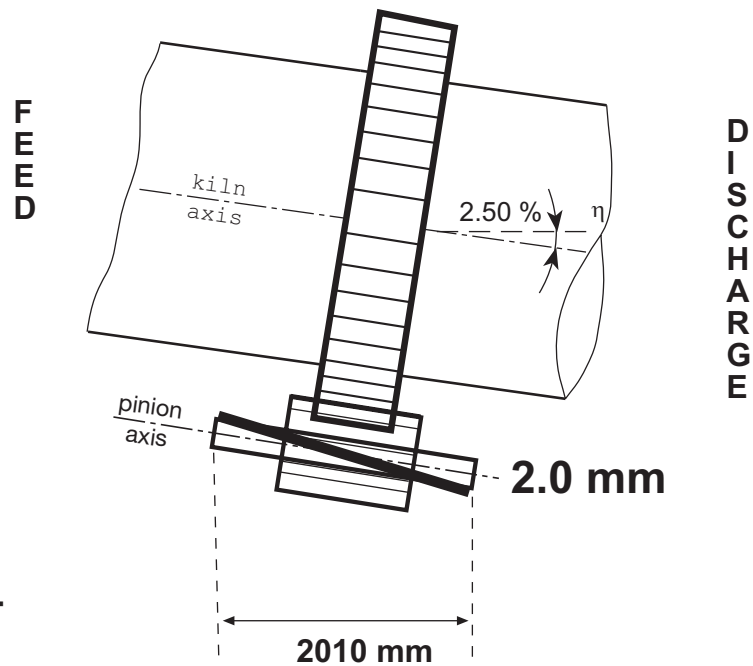
Pinion Axis

- drive pinion axis is deviated by 3.5 mm in horizontal plane and by 2.0 mm in vertical plane (reduced for regulation bolts distance), this deviation is higher than expected for this parameter
- gear rim eccentricity is 4 mm what causes 8 mm change of root clearance
- gear rim eccentricity is caused by kiln shell eccentricity at the gear (see cross section No 24), however the gear eccentricity is smaller than eccentricity of shell in this zone
- gear rim wobbling is not high and equal +/- 1.6 mm

CAUTION!
 Values of pinion axis deviations
 are calculated for regulation
 bolts distance

- drive gear rim and pinion are mechanically worn, all root's working surfaces are damaged, root clearance and backlash are both incorrect
- there is very high vibration caused by improper mesh of the drive
- the pinion should be replaced as soon as possible
- the gear rim should be also replaced and it can not be installed in opposite position (after turning it by 180 degrees) because the roots are worn both sides, the gear replacement should be performed with consideration on eccentricity reduction

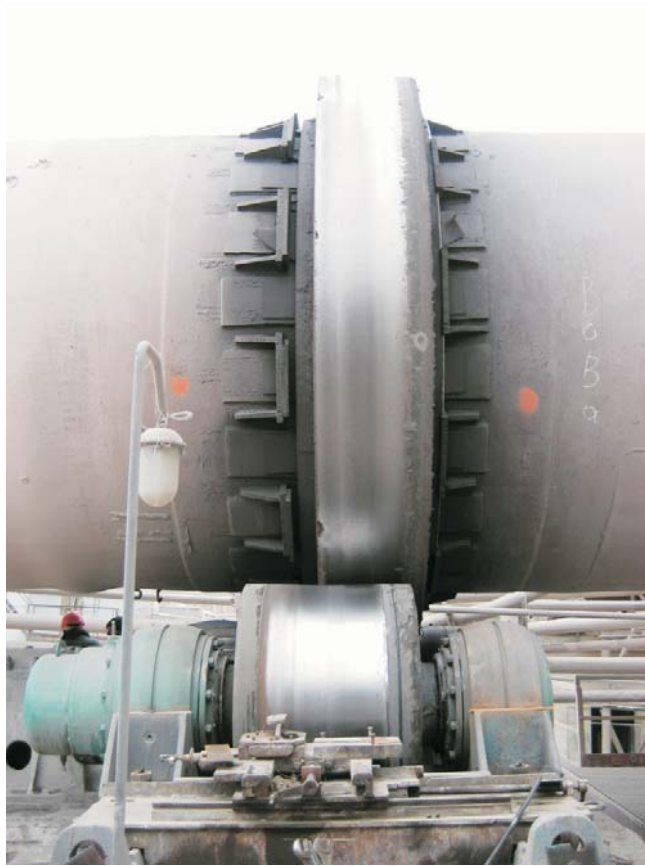
Photo # 1

Tire No 1

Too big clearance between
tire and stopping blocks.

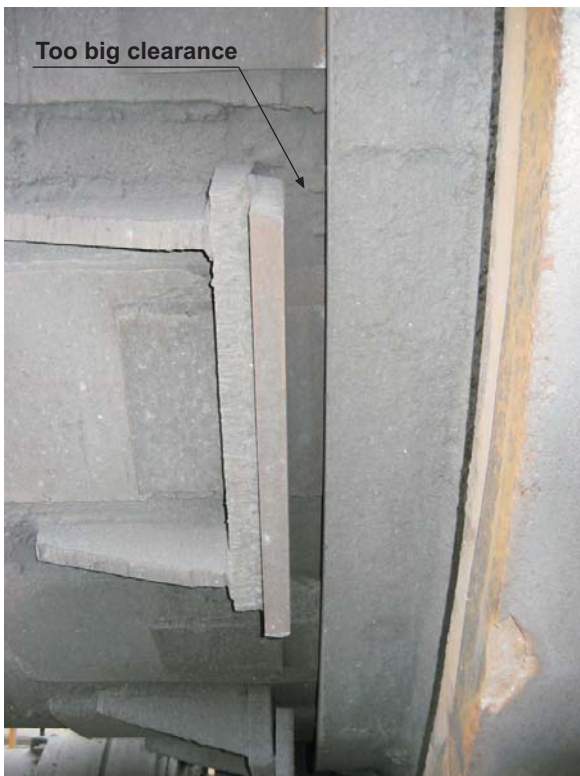
Photo # 2

Lower stopping block

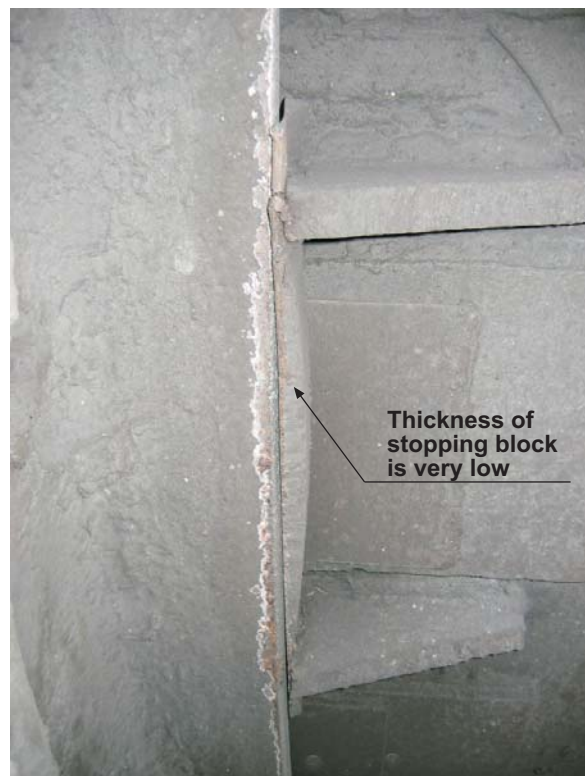
Photo # 3

Upper stopping block

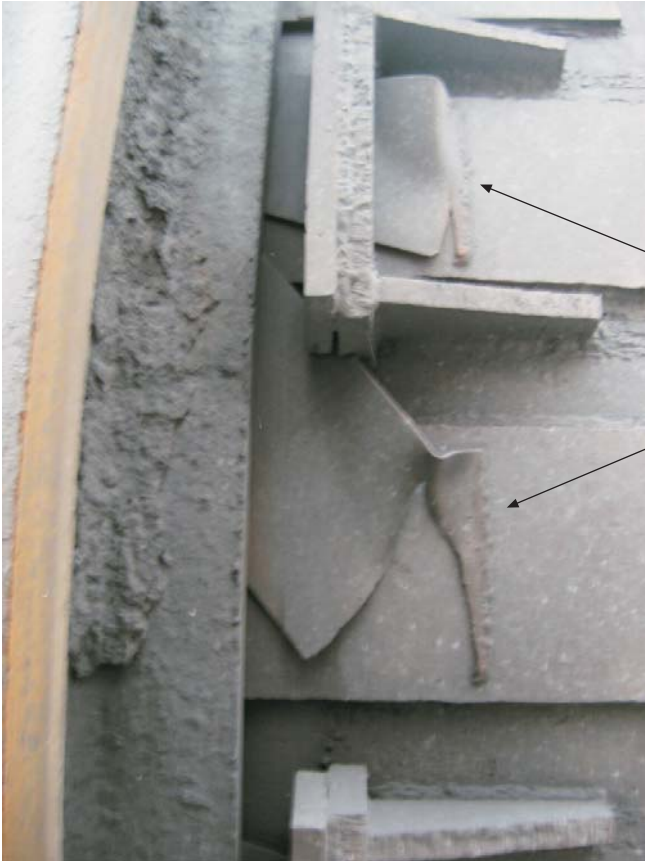
Photo # 4

Tire No 1
Undertire shims are damaged

Small thickness shim should be installed UNDER big shim

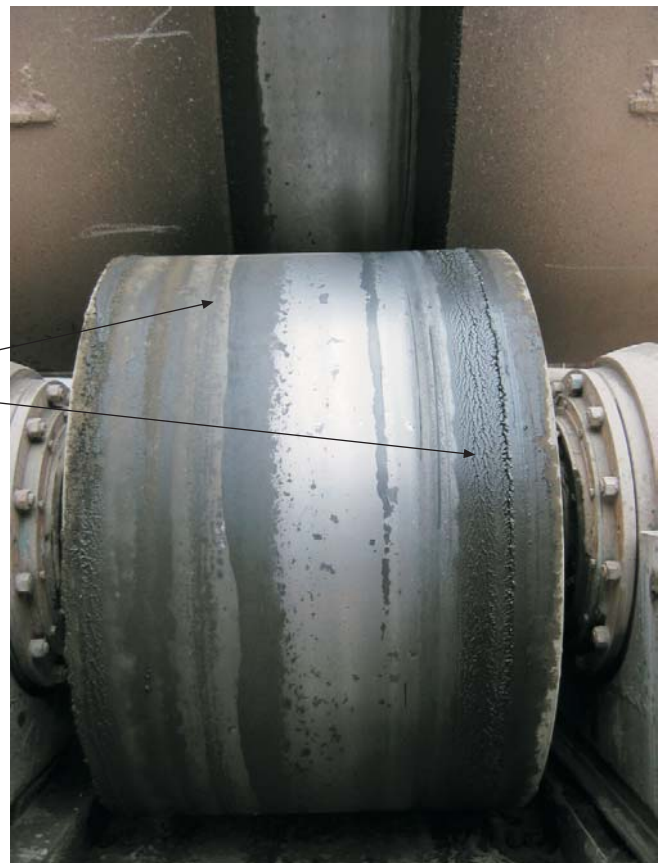
Photo # 5

Rollers are lubricated by grease
what cause components wear-out

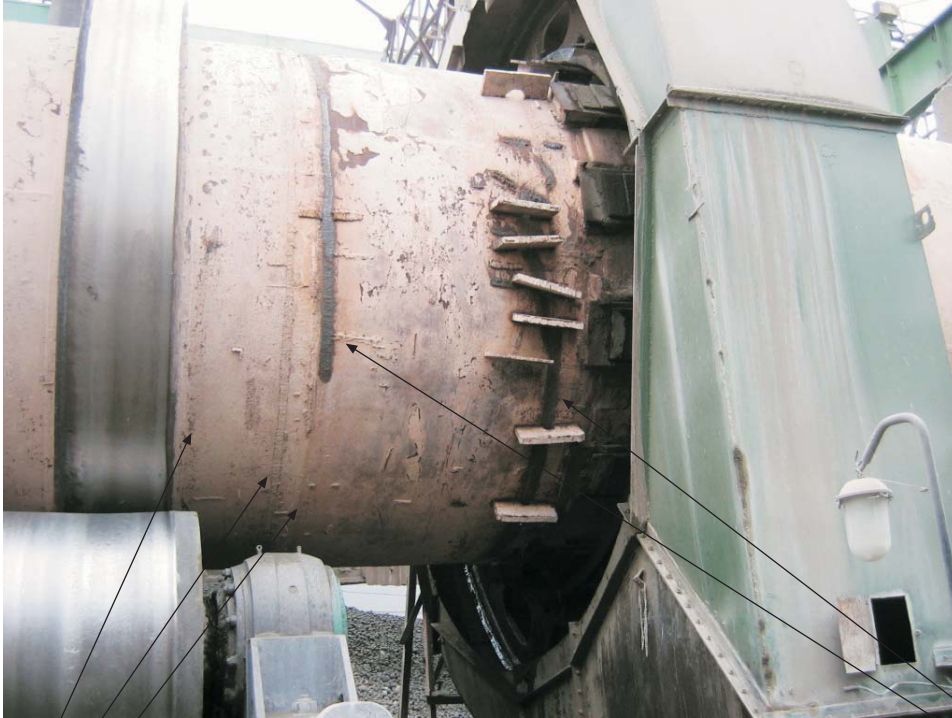
Photo # 6

Drive station

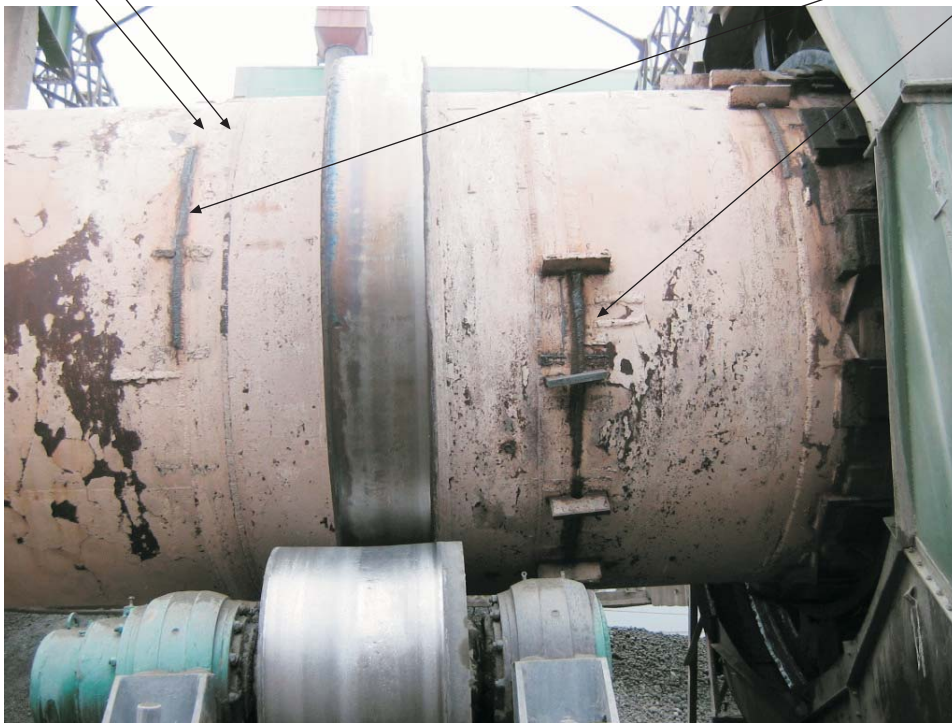
Photo # 7

Weld-joints

Cracks

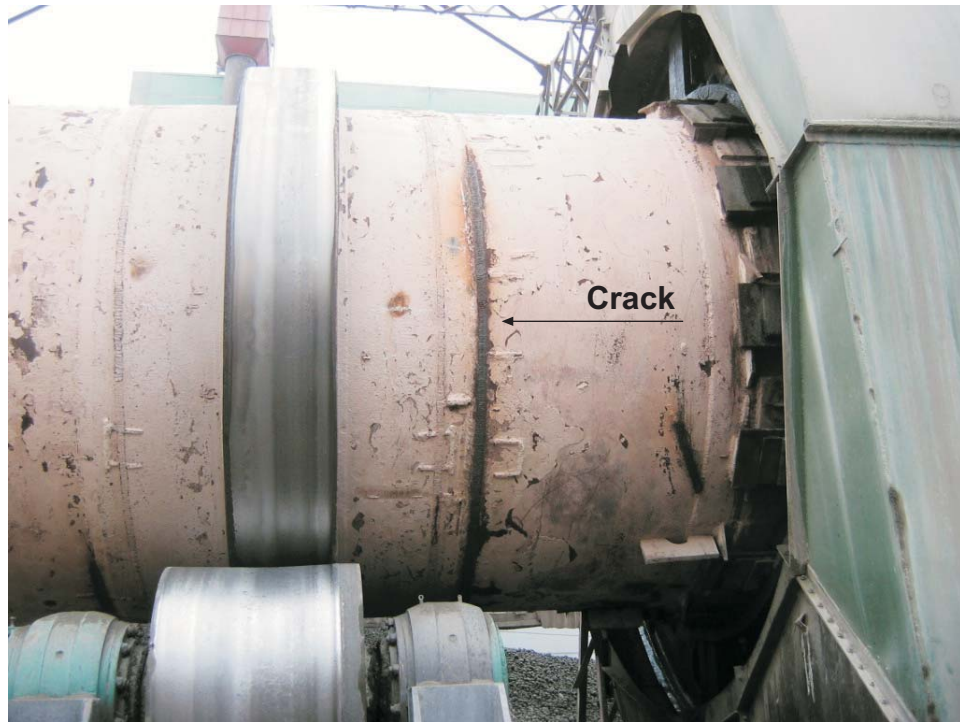
Photo # 8

Drive station

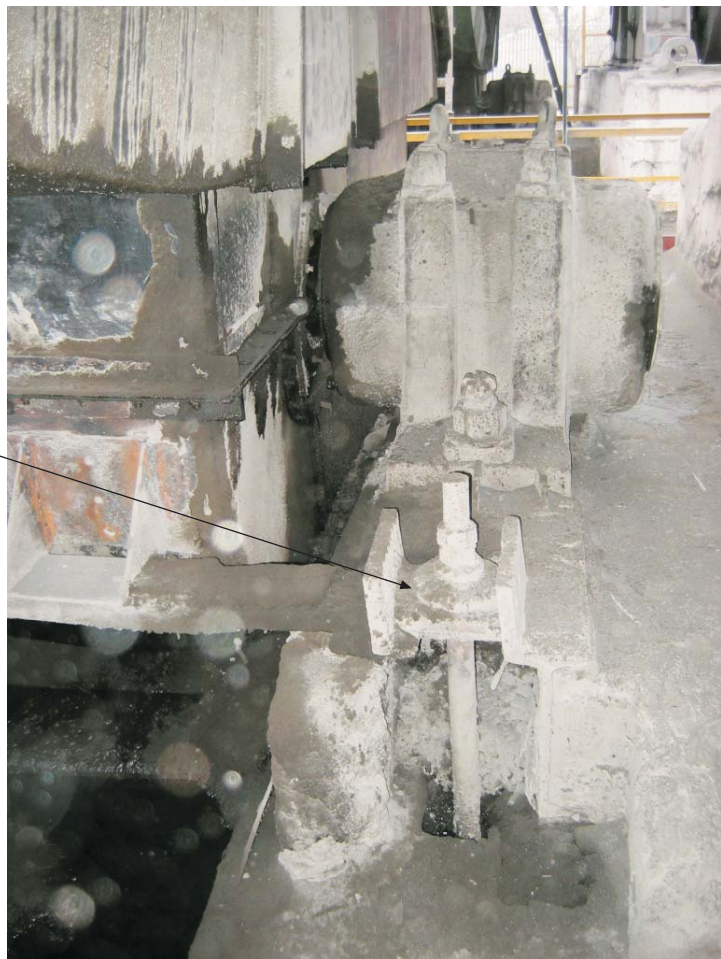
Photo # 9

Drive pinion's foundation frame is loosed and it move by 5 mm

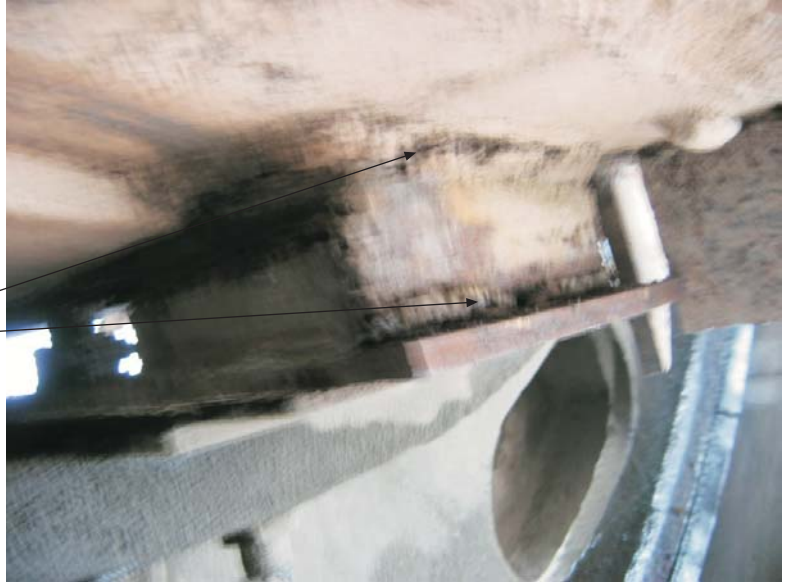
Photo # 10

Girth gear fastening blocks are corroded, plates are loosed, weld joints are ckacked

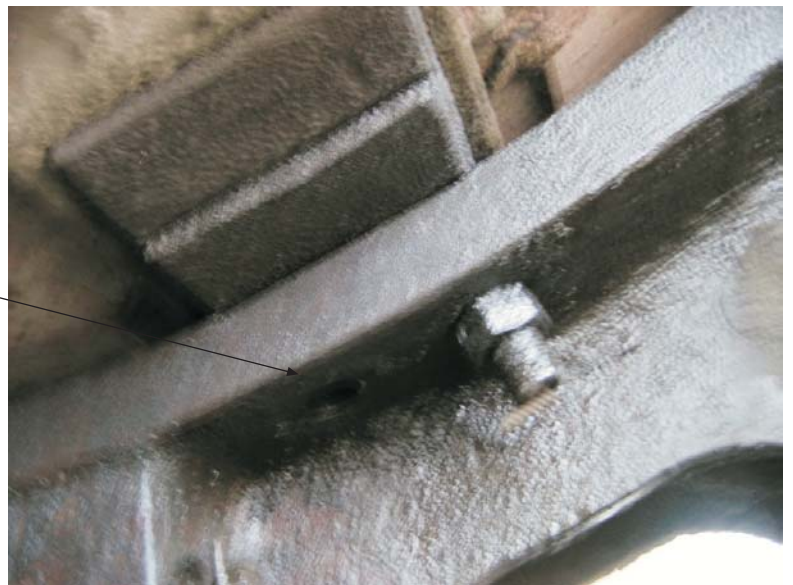
Photo # 12

Some fastening bolts have felt down

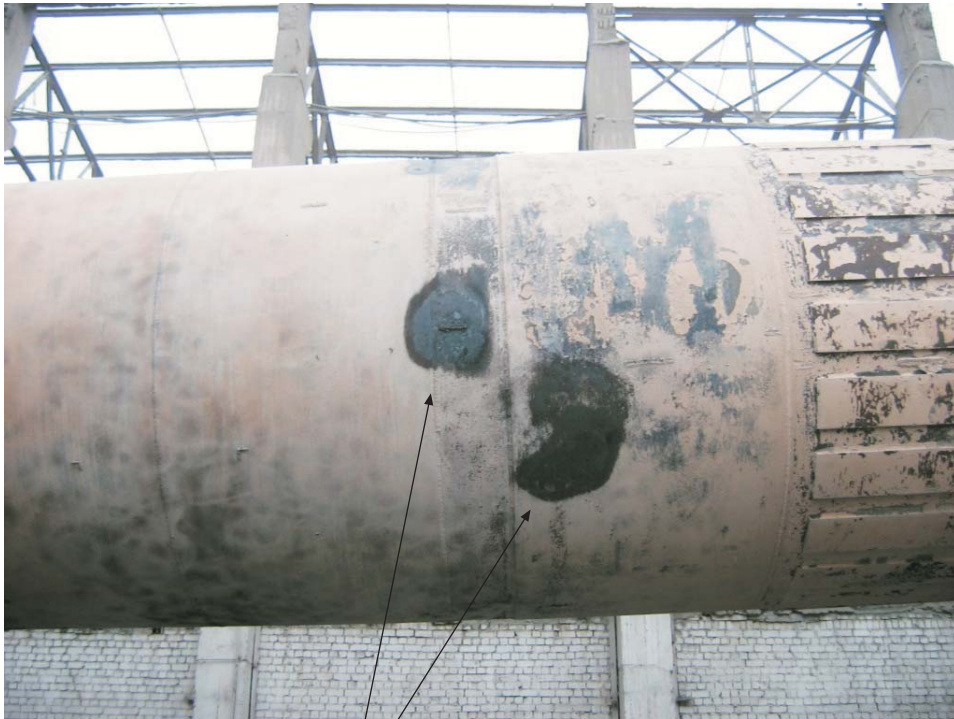
Photo # 13

Shell section between V and VI tire

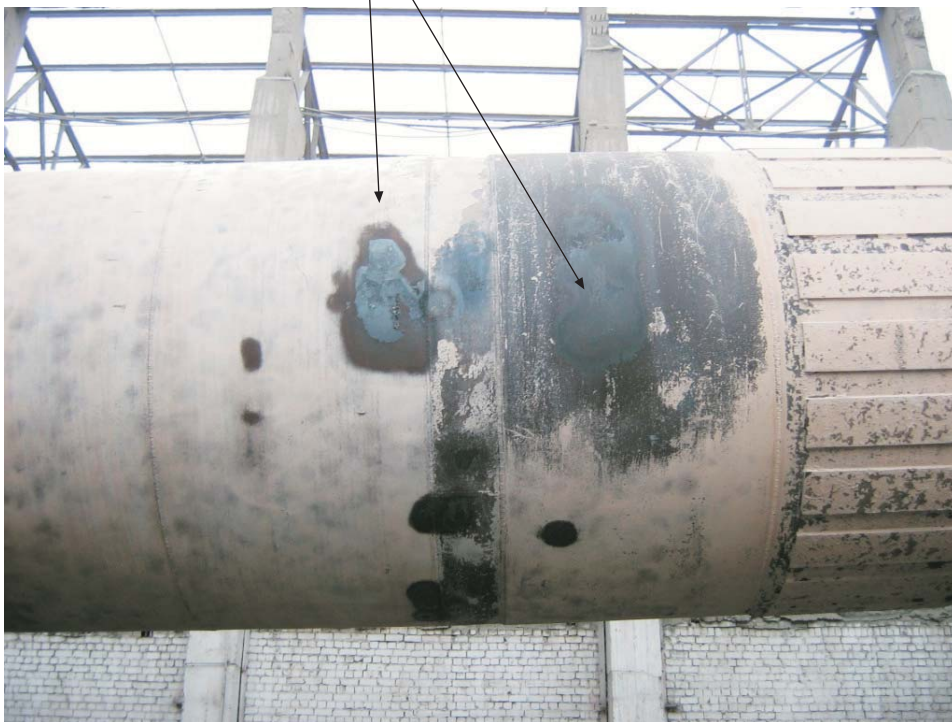
Photo # 14

The shell has been overheated

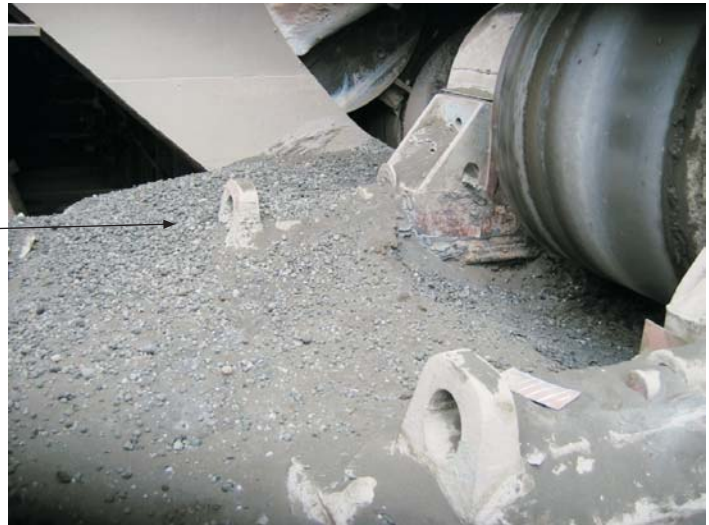
Photo # 15

Sixth pier is permanently covered by clinker dropping from the coolers

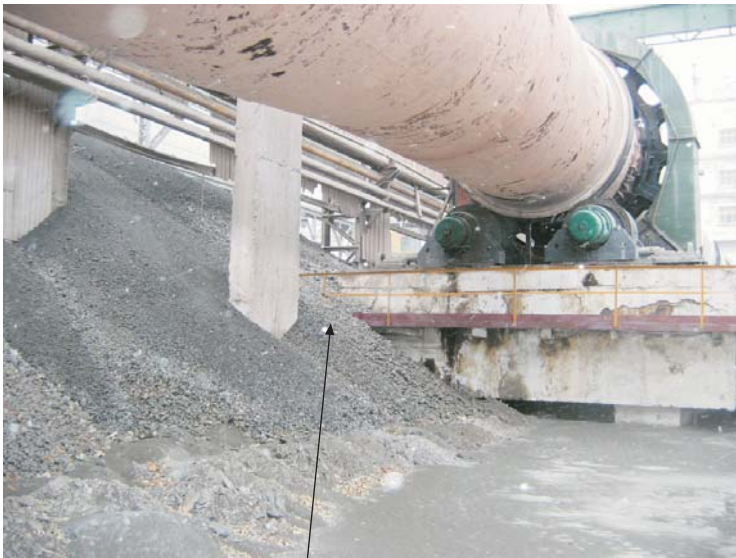
Photo # 16

Clinker stock wall is damaged and kiln piers are surrounded by clinker

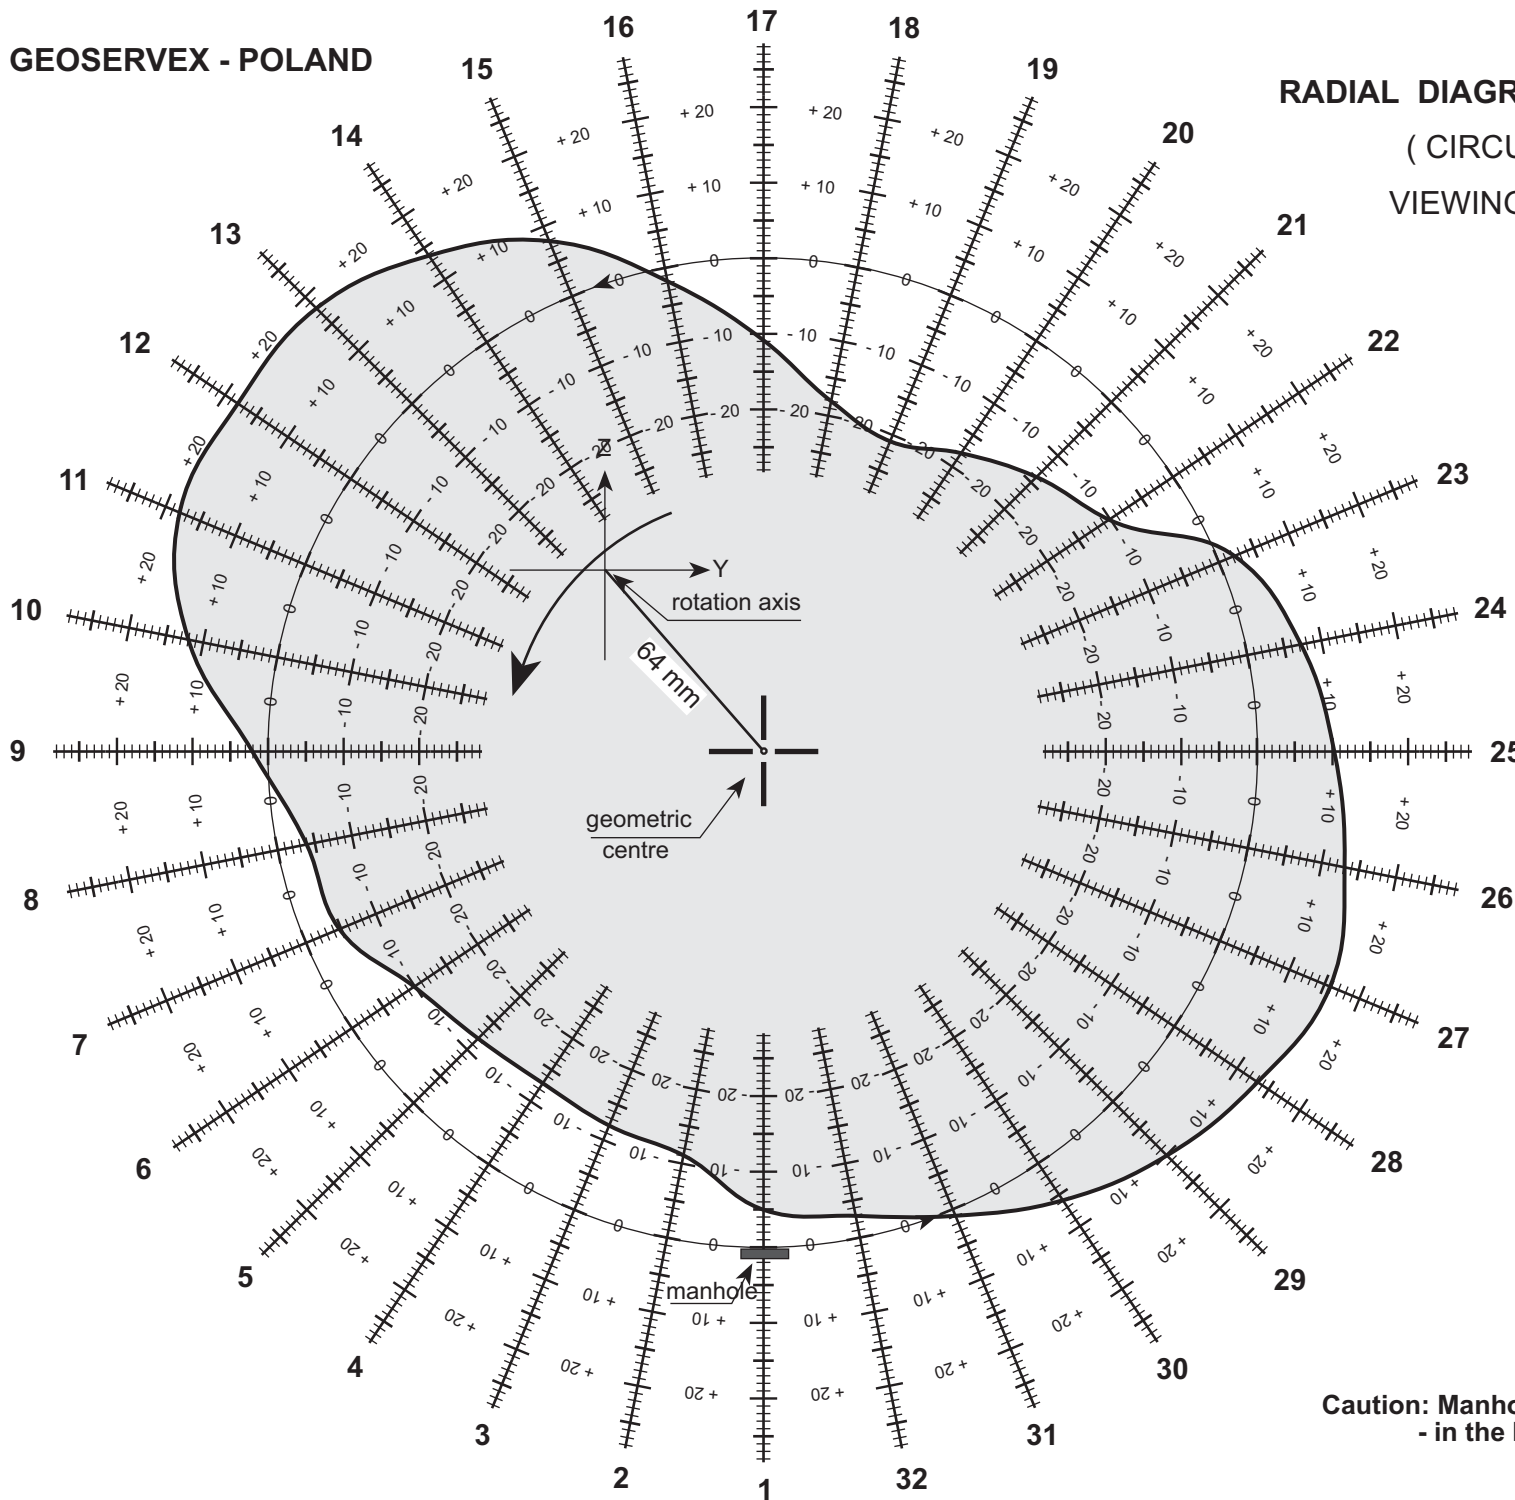
SECTION No 16

- survey of shell deviation was taken in 35 sections shown on the draft
- maximum deviations of the shell (eccentric) rise up to 64 mm (section No 16) and it exceed tolerance several times, there is a huge "banana" formation in this zone

| Y | 42 mm |
| Z | - 48 mm |
| ECCENTR | 64 mm |

The kiln shell deformations is very high in several places. This deformations has serious influence on refractory life-time. If refractory loss had place in a zone where shell deformations are serious , this part of shell should be replaced.
