RESULTS OF DEVIATION MEASUREMENTS AND GEOMETRY OF ROTARY KILN No 1

AT EXEMPLARY CEMENT PLANT

**PERIOD OF SURVEY:
30th of March - 16th of April, 2004**

FINAL REPORT ON KILN No 1

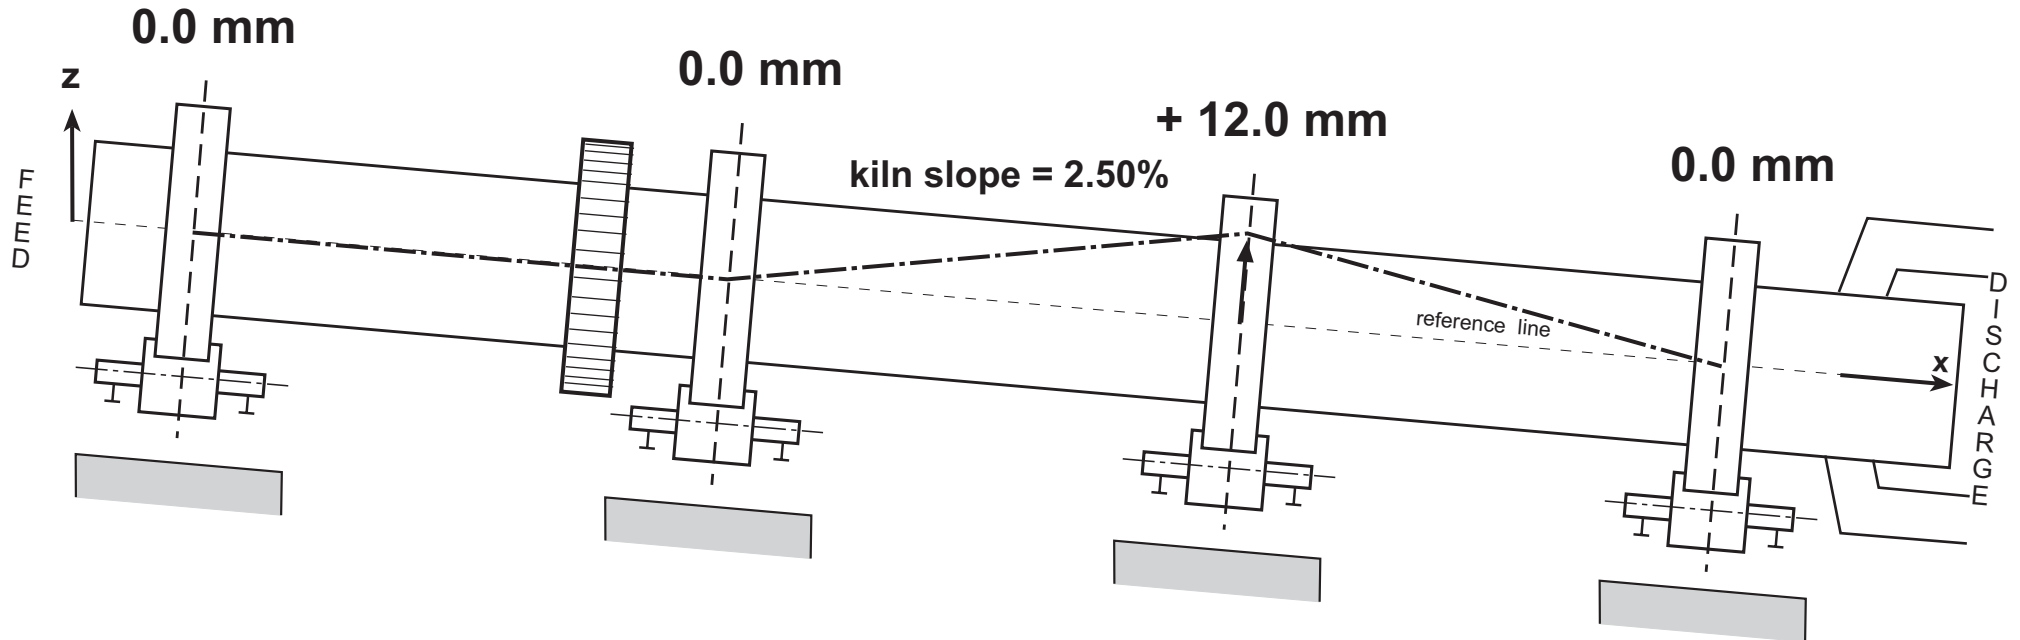
**Axial Deviations
In Vertical Plane**

- kiln axis in horizontal plane is deviated by 19 mm on second pier and 11 mm on third pier and require adjustment
- kiln axis in vertical plane is deviated by 12.0 mm on second pier and require adjustment
- undertire clearances are slightly too large for tires No 1,2,4 and it's incorrect for tire No 3 where it rise up to 14 mm. The clearance should be corrected by inserting shims at the nearest kiln stoppage. Too large clearance may cause too high shell ovality and as a result refractory loss.
- kiln slope is 2.50 % and it's correct.

1. Kiln axis should be adjusted to proper position in horizontal and vertical plane by shifting rollers on first and second piers what has been discussed and agreed with plant representatives.
2. It has been agreed that vertical adjustment axis on second pier should remains 6 mm over straight line connecting remaining axis points (Adjustment program, VERSION I) , what is recommended by the kiln producer (FLS)
3. It has been agreed that the adjustment should be done in small steps by plant crew according to adjustment program prepared by Geoservex
4. First 16 steps (first day of adjustment) has been performed under supervision of Geoservex team, there was no problems with shifting of the rollers, reference system is clearly marked on foundation frames

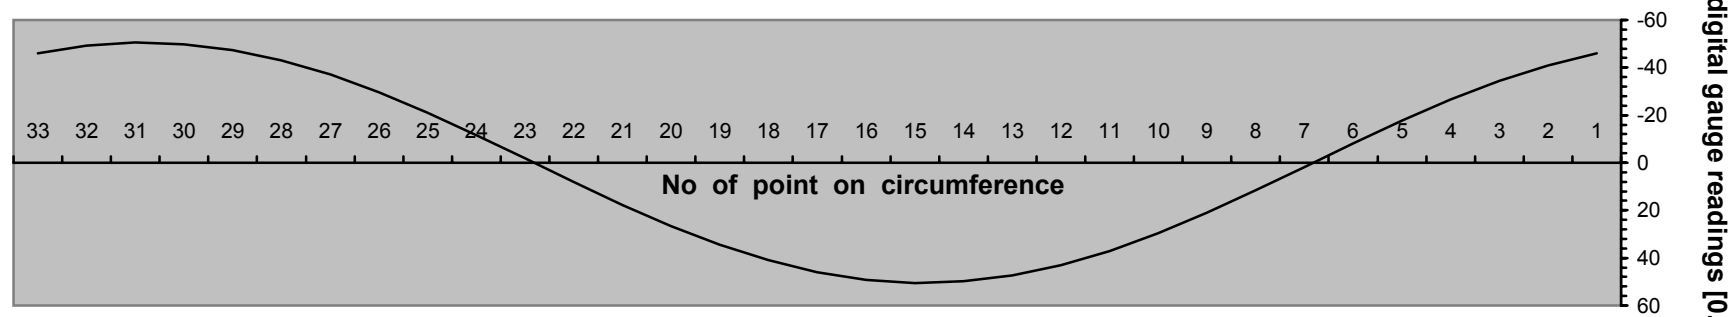
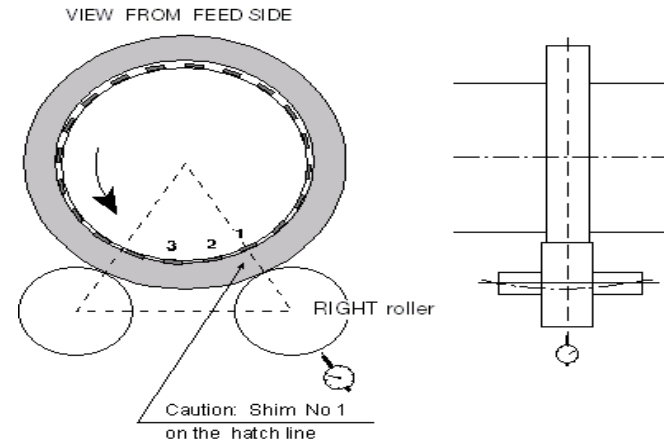
Pier No III - NORTH roller

- roller shaft deflections doesn't exceed value of 0.11 mm (eccentricity) while the tolerance given by kiln producer (FLS) is 0.15 mm
- roller shaft deflection are caused by mechanical crank of the shell however the crank formation in the shell is smaller than that which is normally considered dangerous

Eccentricity: 0.05 mm
Total value of deflection: 0.10 mm
Maximum deflection angle: 205 deg

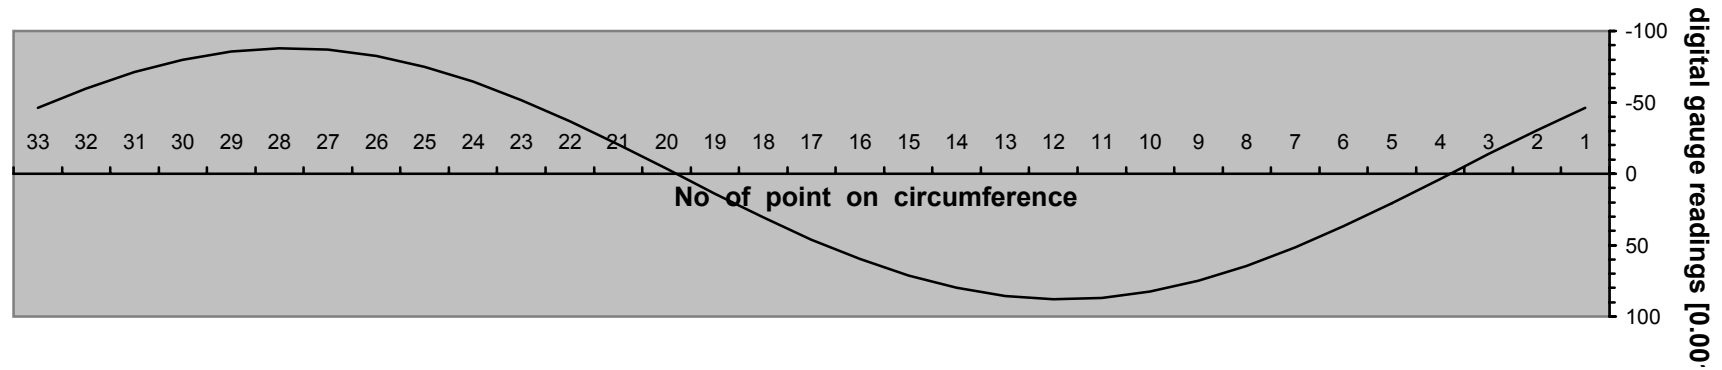
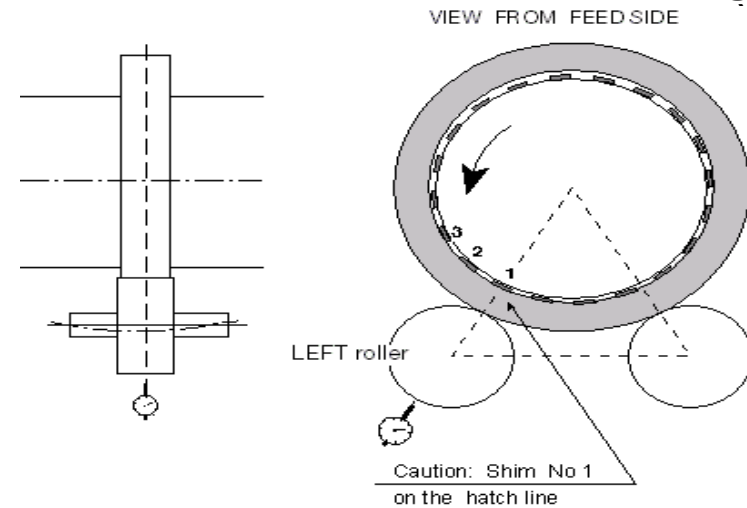
Pier No III - SOUTH roller

Eccentricity: 0.09 mm
Total value of deflection: 0.18 mm
Maximum deflection angle: 238 deg

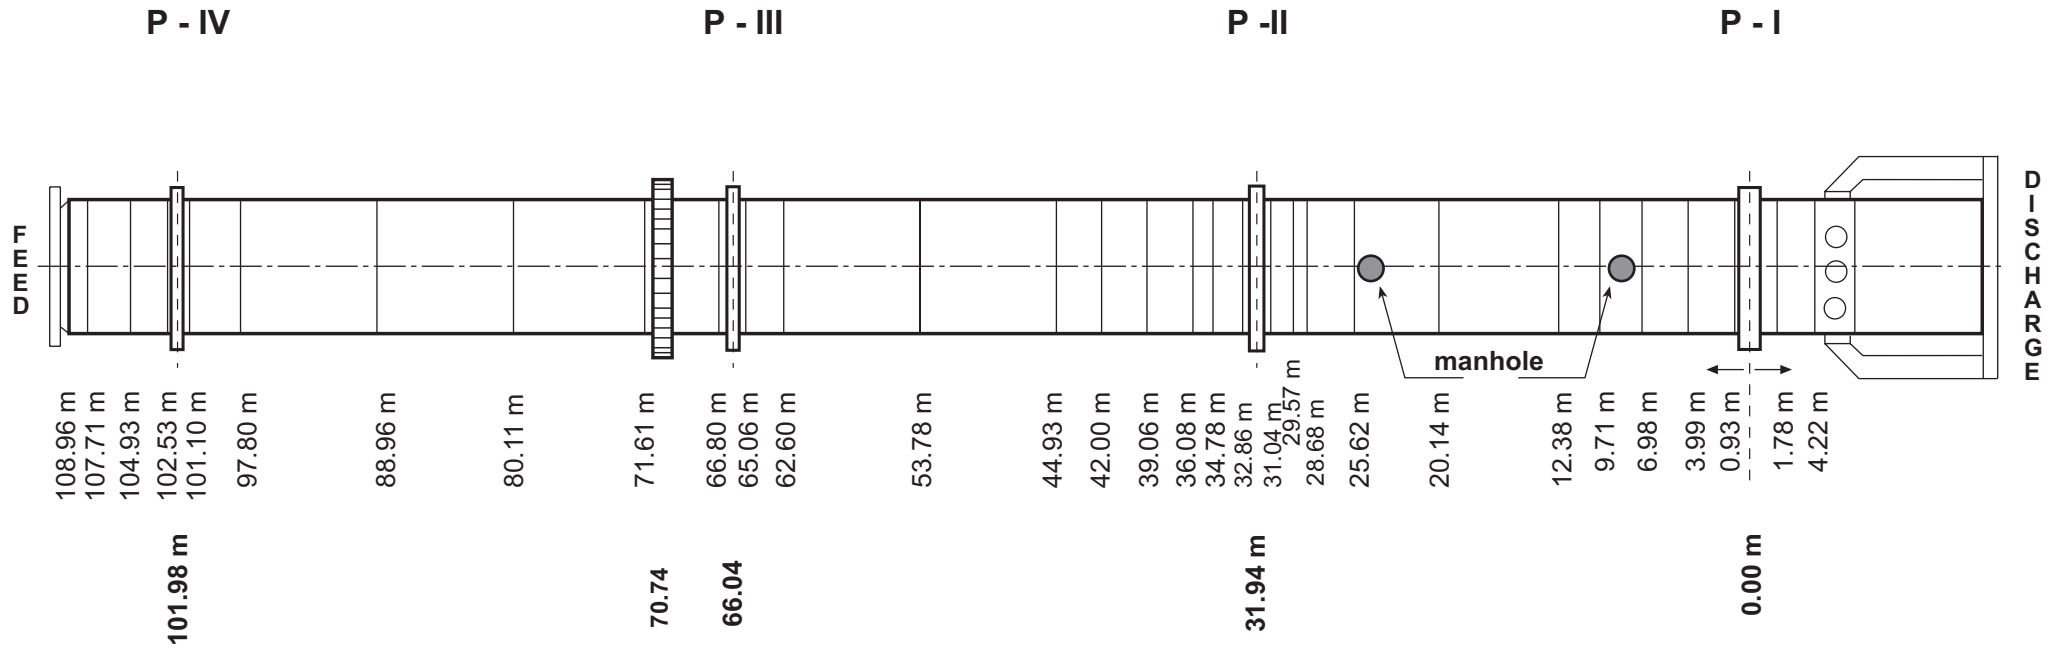
SUMMARY DIAGRAM OF SHELL DEFORMATION

- deviations of the shell surface (circular deviations) exceed tolerance for cross sections No 5 and No 16 to No 32.
- deviations of the shell surface (circular deviations) from section No 17 to No 22 is critically high and rise up to +/- 35 mm, replacement of this shell portion should be taken under consideration if any refractory loss had place in this zone

The kiln shell deformations is very high in several places. This deformations has serious influence on refractory life-time. If refractory loss had place in a zone where shell deformations are serious , this part of shell should be replaced.
